To fix this firmware bug you will need to.....

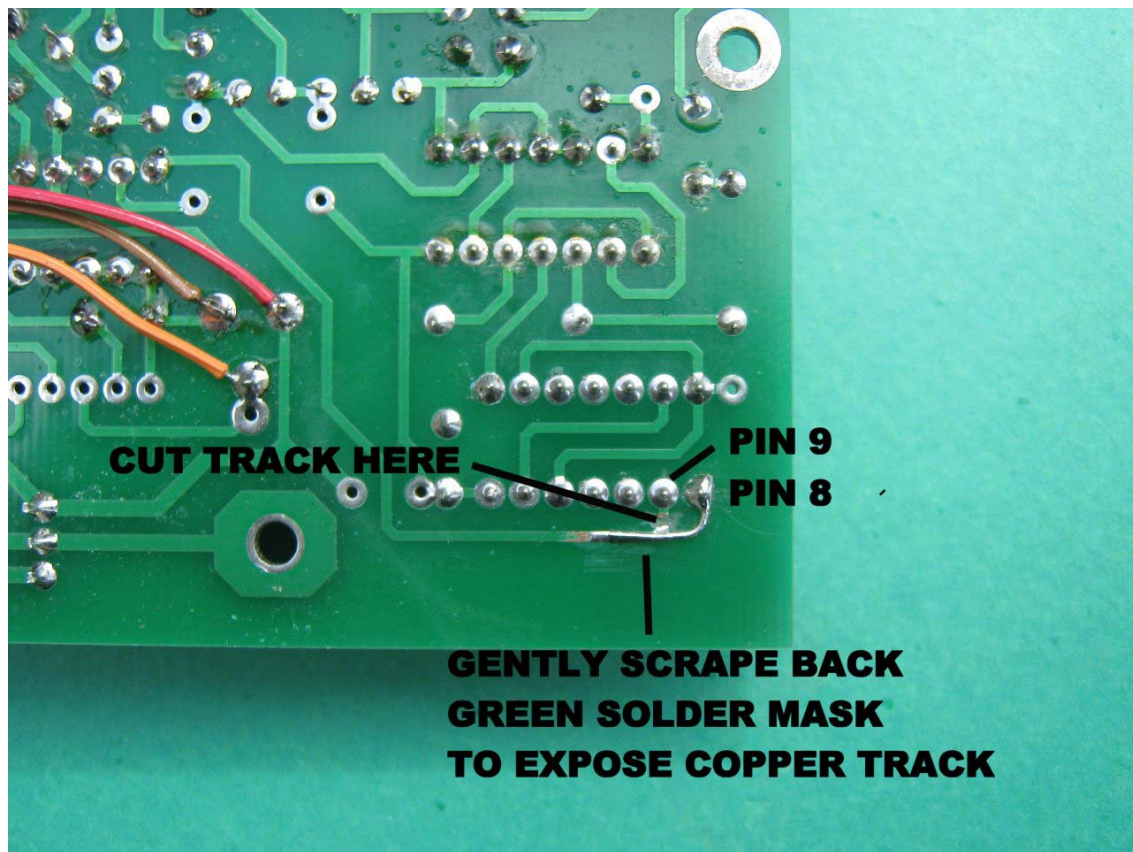
Cut the clock rate to the processor (pin 14) by a factor of 2 by including an extra flip flop into the 74HC393 divider chain. So cut the track to pin 9 of the 74HC393 and connect this track to pin 8 of the 74HC393. See the attached photo below.

Reload the Picaxe 28X2 with the new VK5JST code now up on the homepage. This doubles the gate time in the frequency counter function generating correct frequency displays. See the instructions elsewhere on the web page on how to load the Picaxe with code.
